NRL/MR/7130--03-8685

Preliminary Observations Regarding LDV Scans of Panels Excited by Broadband Actuators at the U.S. Capitol

J.A. BUCARO
J. VIGNOLA
B. H. HOUSTON
A. J. ROMANO

November 7, 2003

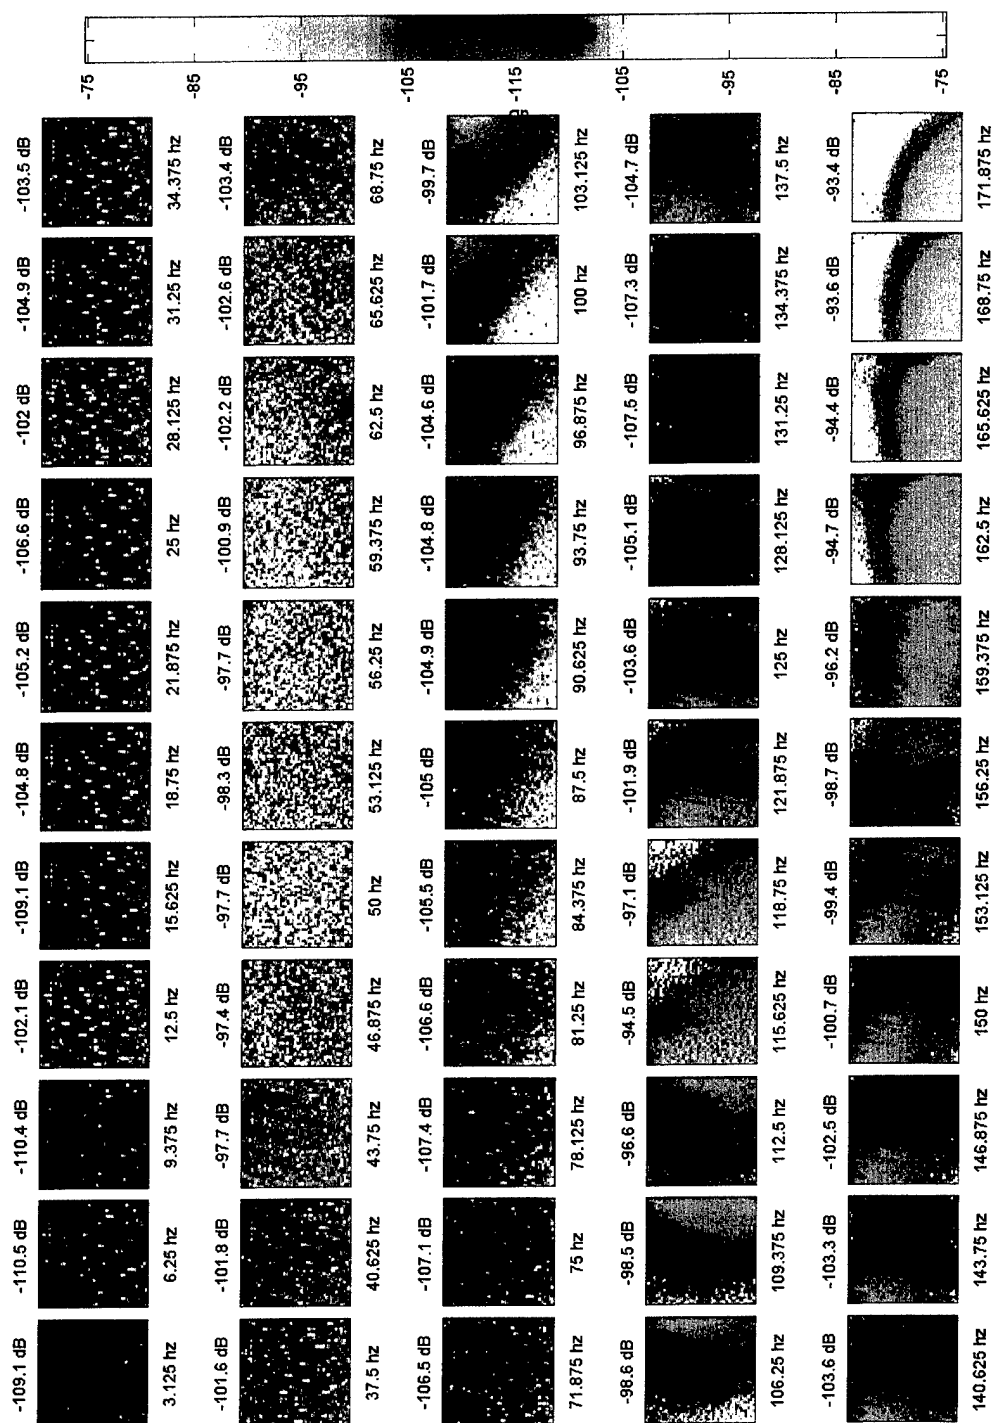
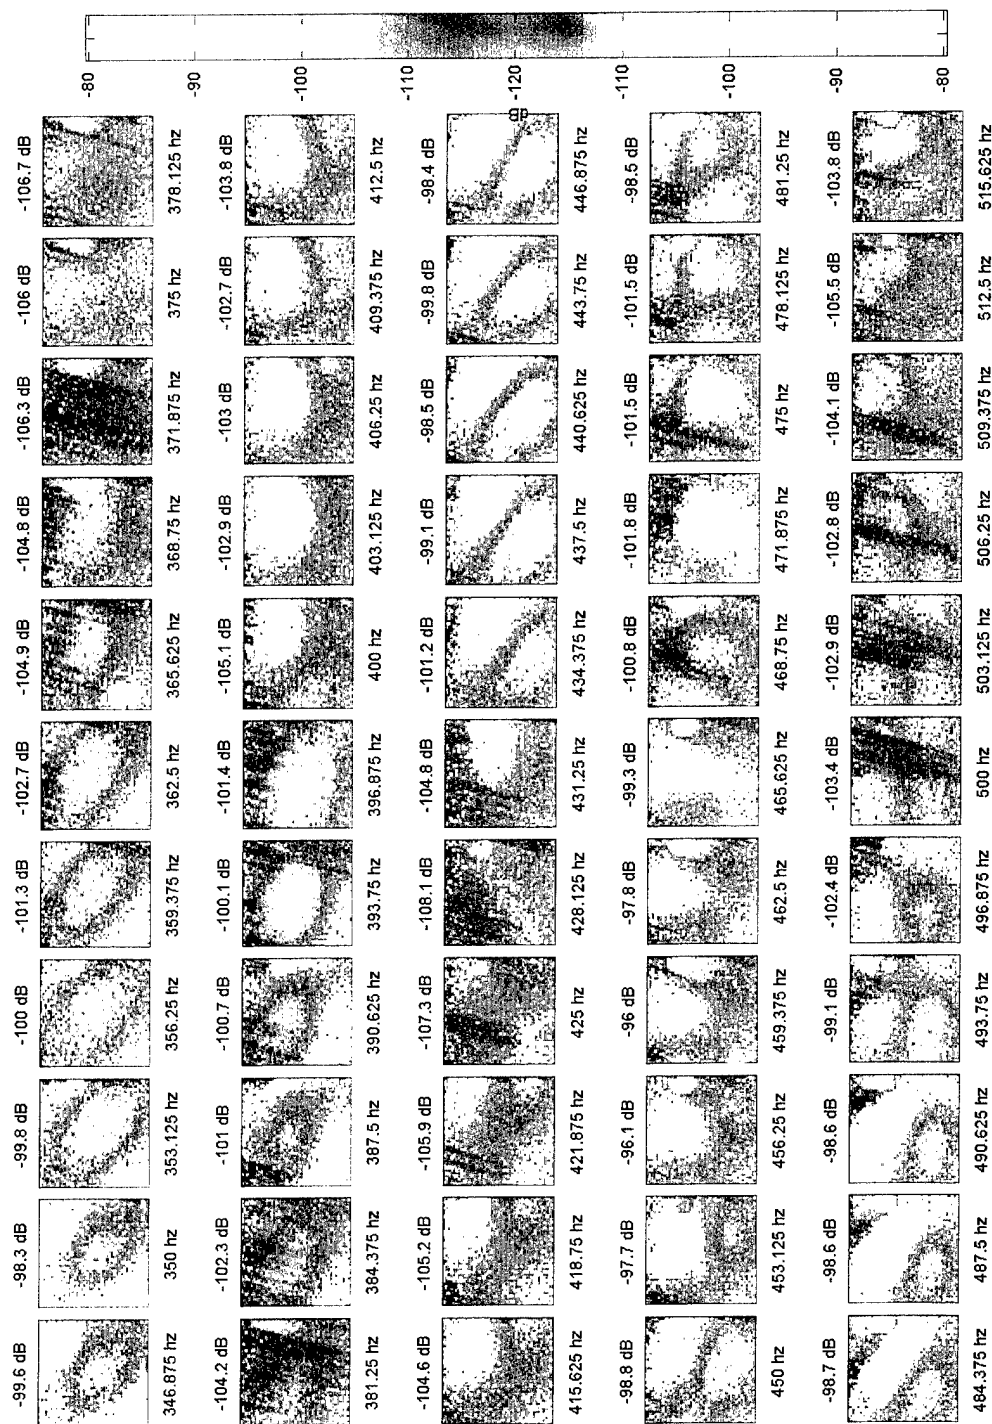
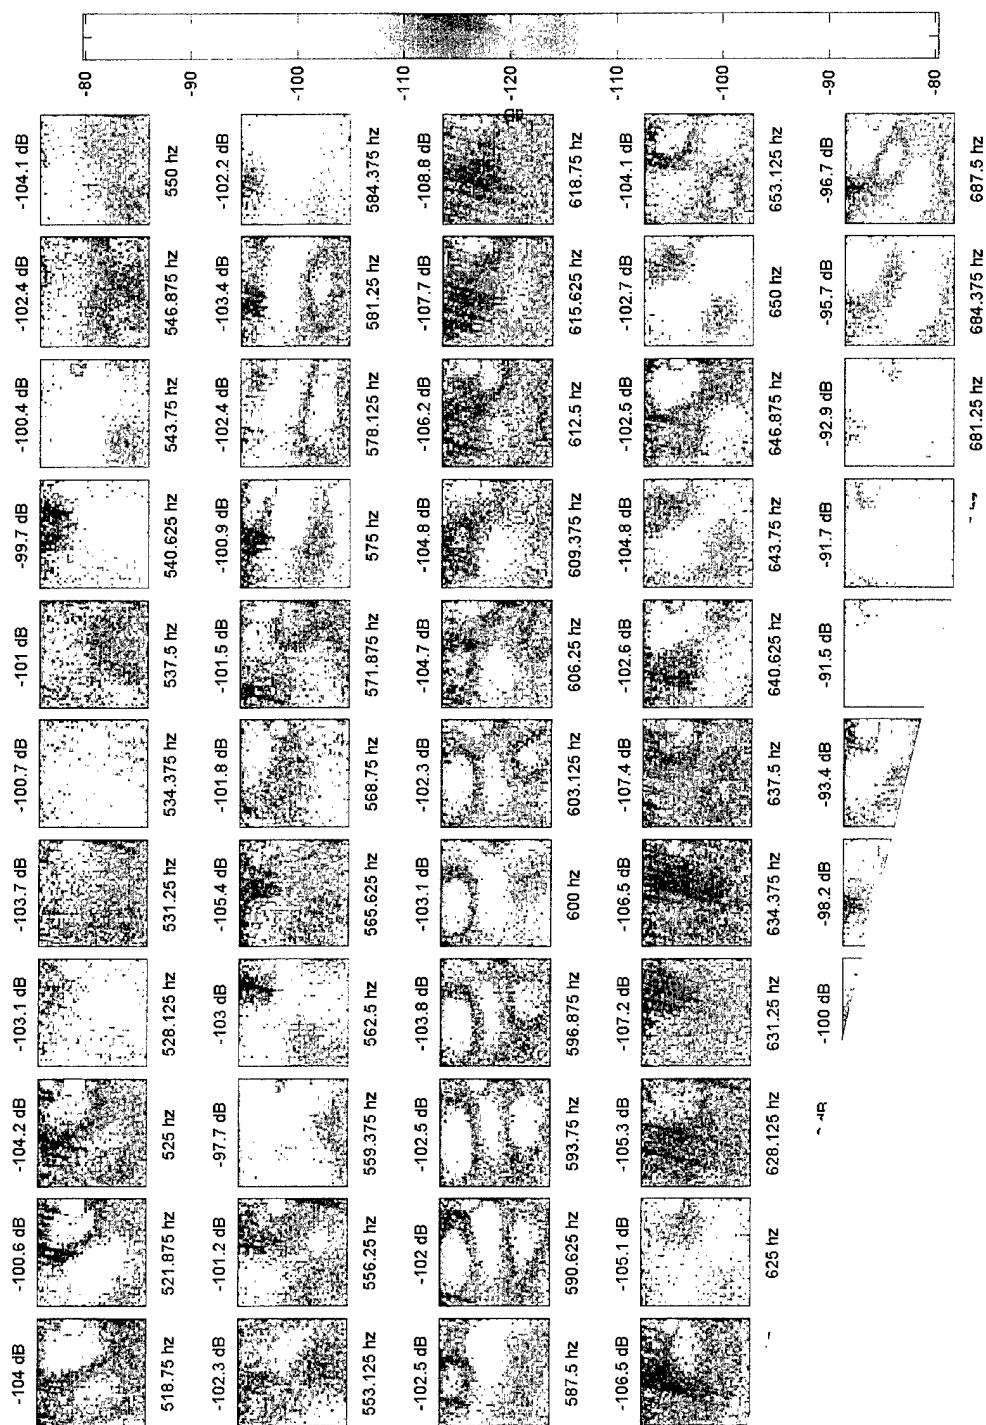
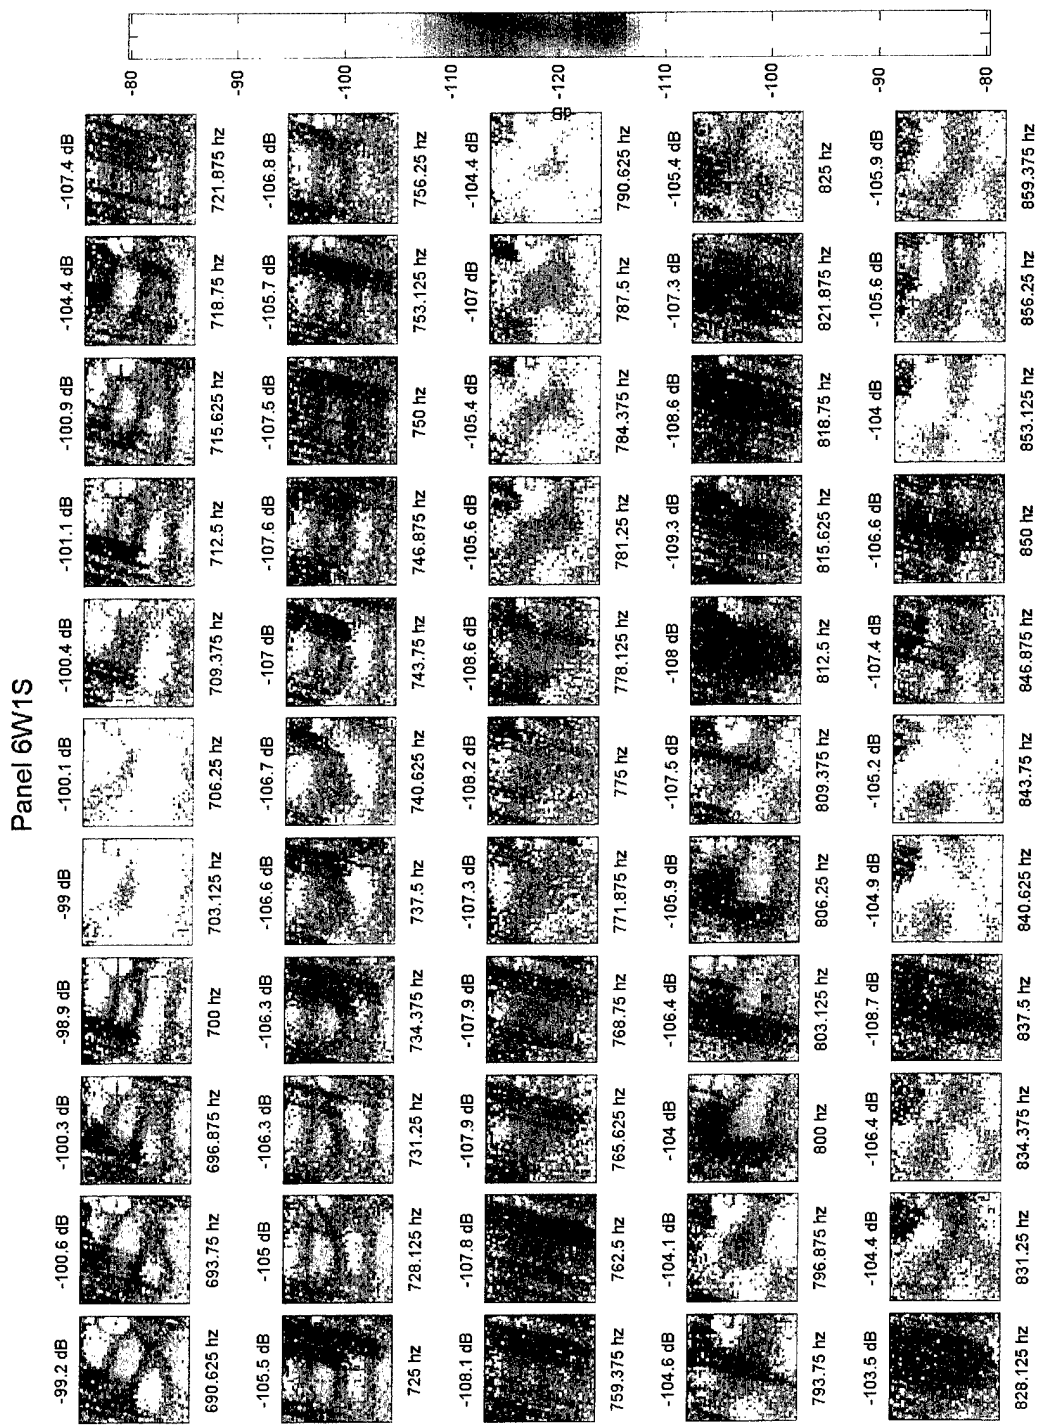
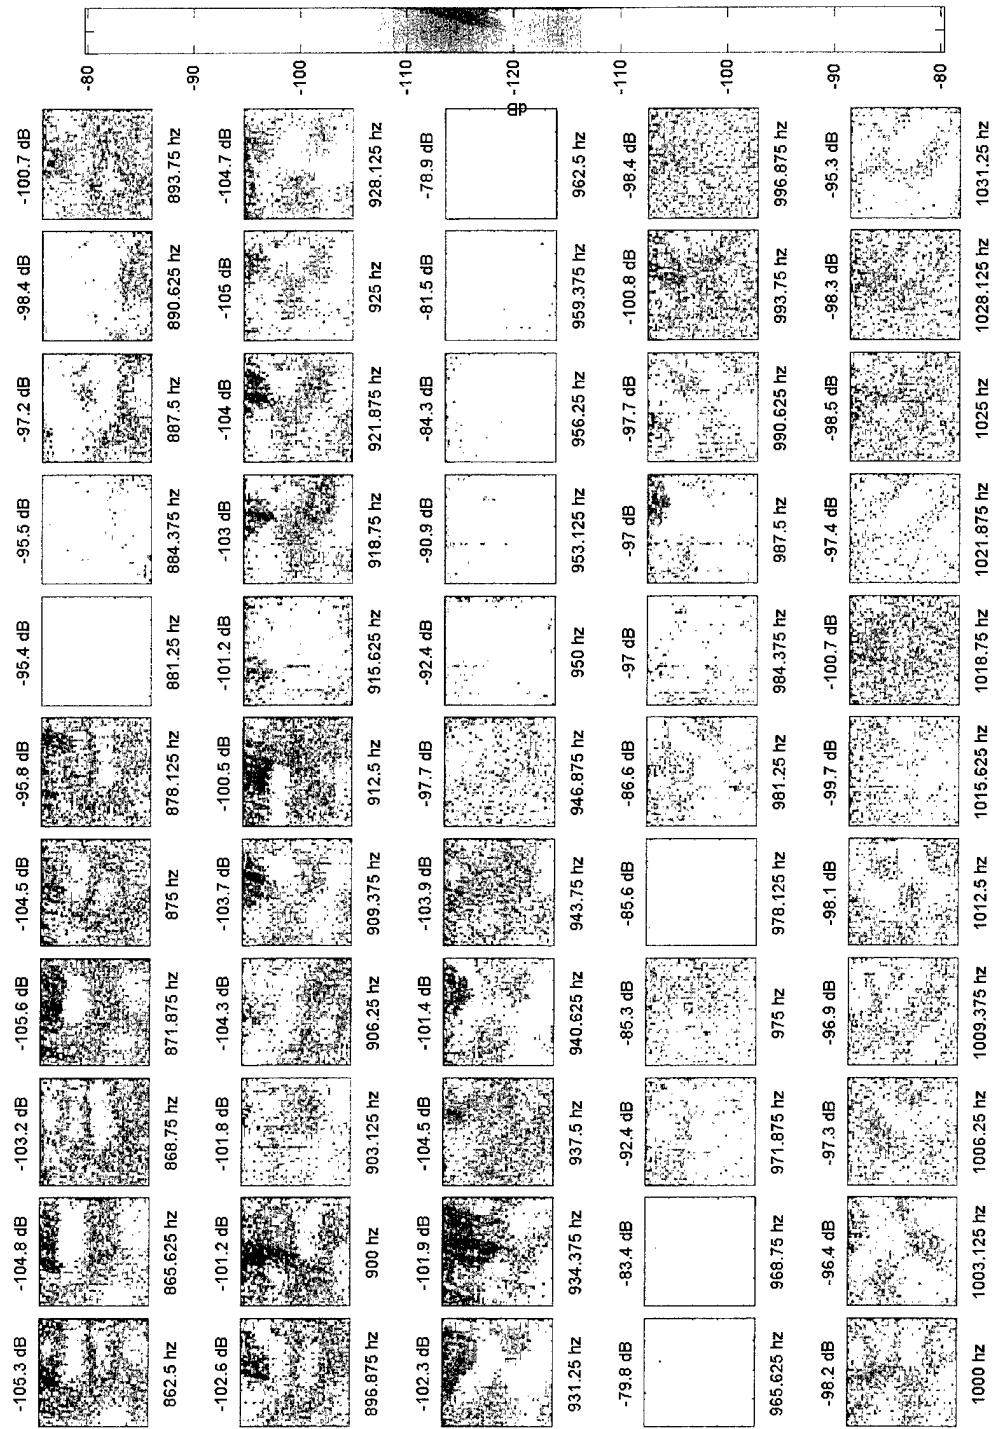
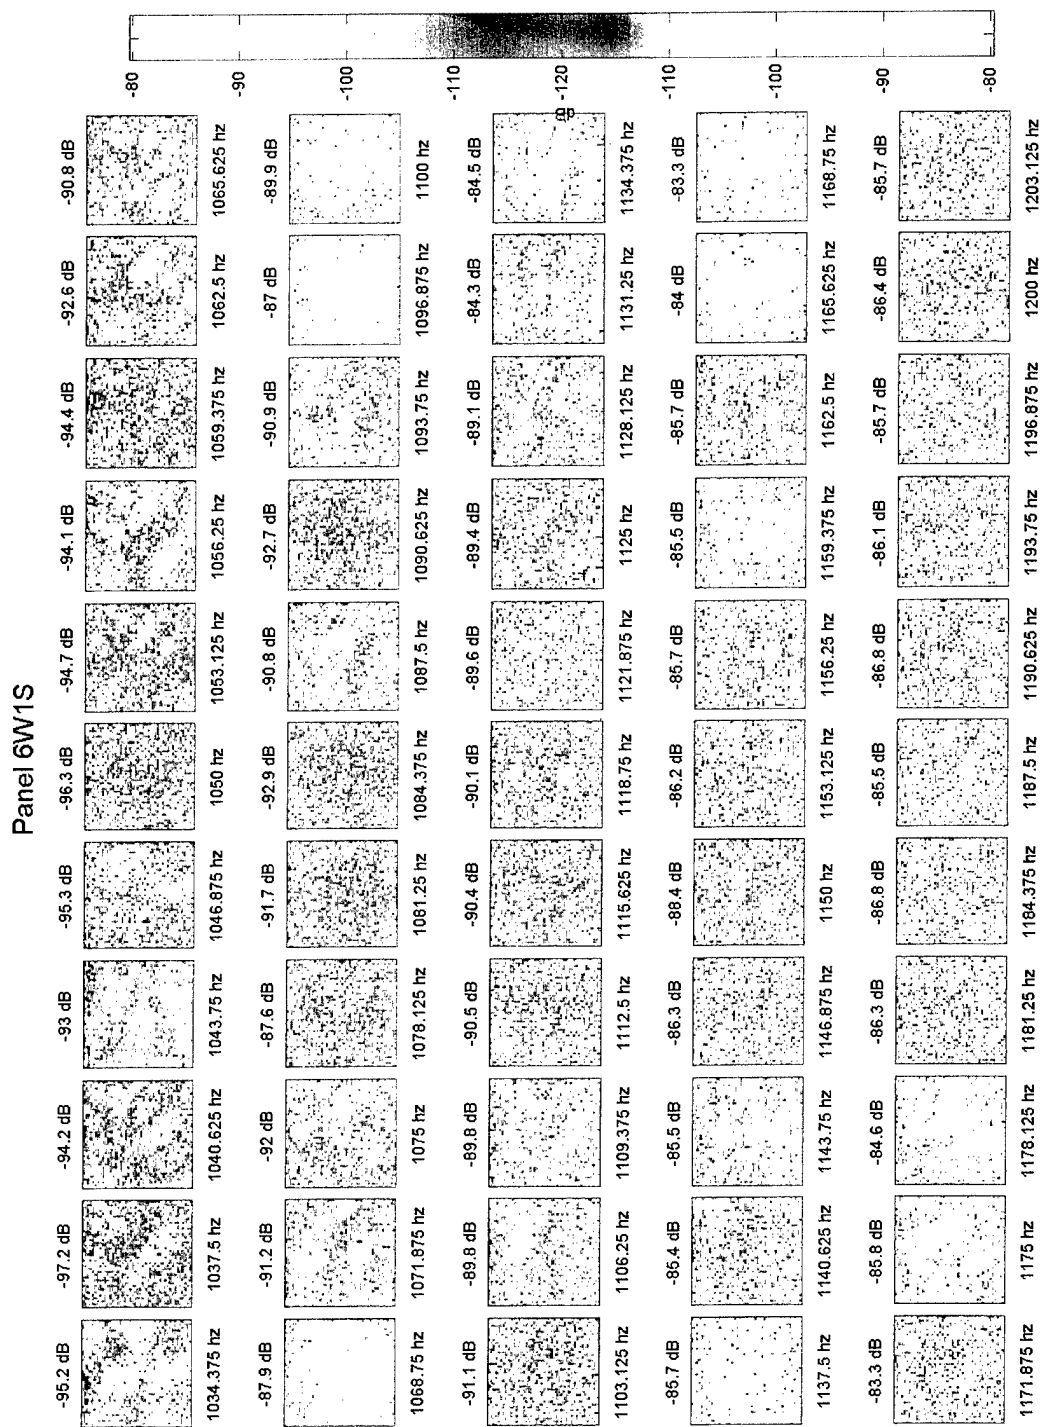
We first discuss the measurements taken on Panel 1 (see Fig. 1). Simple sequential observations (see Figs. 2a - 2g and Figs. 3a - 3f) of the velocity scans (phase and amplitude) at each three Hertz increment indicate that we have obtained meaningful data on panel 1 over the band from about 80Hz to 1KHz. From 80Hz to about 400 Hz we can observe what appears to be simple wave propagation from the lower left corner where the actuator is located up toward the upper right hand corner. This seems especially clear from the phase plots. The wave speed is very crudely estimated to be about 700 m/sec over this lower band, suggesting shear wave propagation in the plaster. Beginning just below 400 Hz one can see even higher motions over a smaller patch size (about 18cm by 26 cm) near the right edge just above the scanned panel center. It appears strongest at about 460 Hz and seems to fade in and out with something like a 25-40 Hz period. At about 670 Hz, the motion over this patch breaks into a two-lobe mode pattern. Both the extent and location of this mobile patch coincides with a defect area discovered earlier in the tap test data. We should point out, however, that the same tap test data seems to indicate another defect area on the left, a location where we do not see any obvious localized high levels of motion in the LDV maps in this frequency band.
